MARES SERVICE MANUAL

R2S
1ST STAGE

MAINTENANCE PROCEDURE

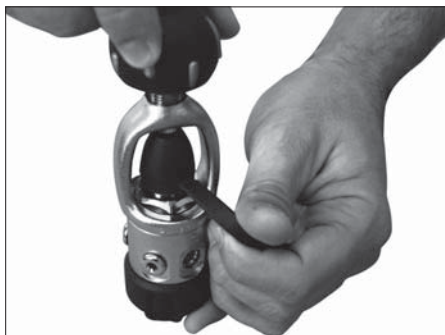
FIG. 1

1. Loosen the dust cap (REF. 10) from the 1st stage, fully unscrewing the yoke knob (16) (Fig. 1).
2. Unscrew the hose protection from the body of the 1st stage. (Fig. 2).

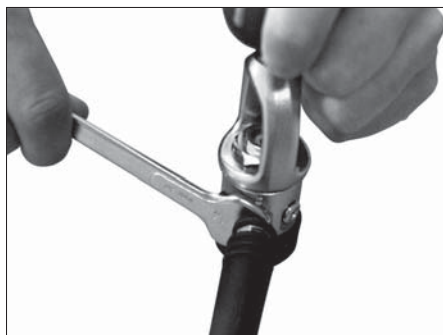
FIG. 3

3. Unscrew the hose (26) using a 14-mm open end wrench (B-18) (Fig. 3).
4. Use the B-41 tool to remove the R2S Cap (Fig. 4).

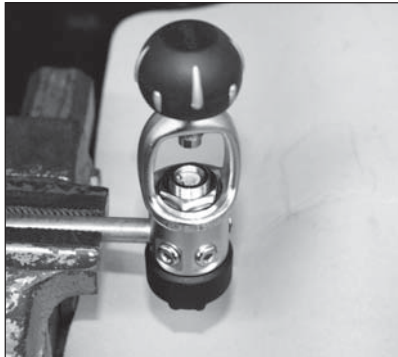
FIG. 5

5. Screw the tool (B-5) to help disassemble the first stage into a 3/8 low pressure port (Fig. 5).
6. Using the Pin Wrench (B-13), unscrew the cap (19), and pull out the complete piston (18) and the spring (4) (Fig. 6).
7. Using the extraction tool (B-22), pull out the Piston Seat (Fig. 7).

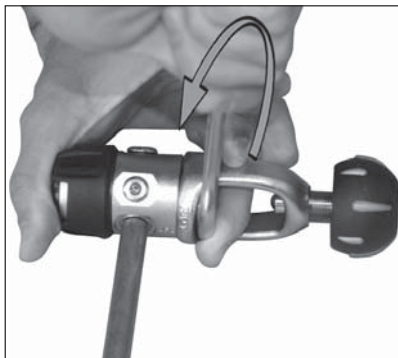
FIG. 8

8. Using the special 25-mm wrench (B-1), unscrew the Yoke retainer nut. (Fig. 8)

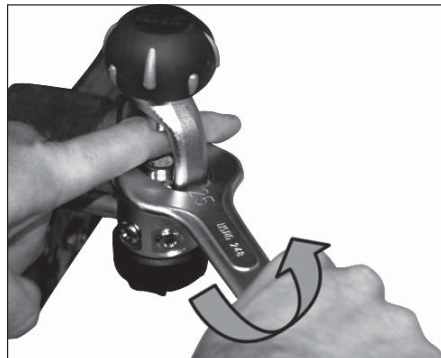
NOTE TO MAKE DISASSEMBLY EASIER, WE RECOMMEND THAT YOU PLACE THE FIRST STAGE IN A BENCH VISE.

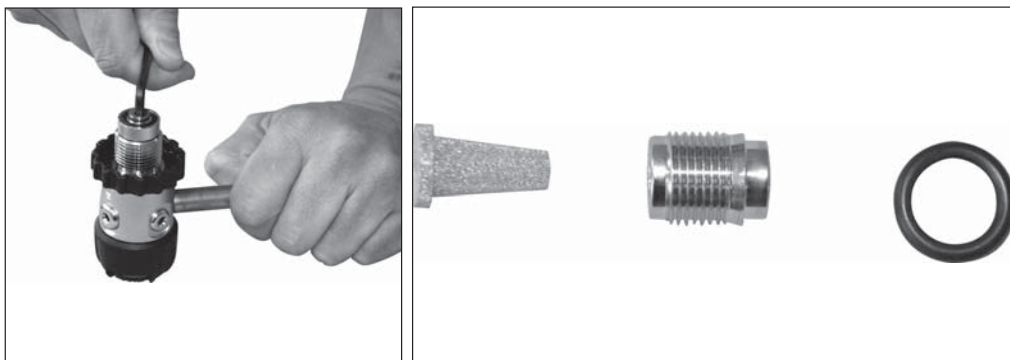
FIG. 1

1. Unscrew the DIN OR seat (15) from the DIN fitting (24) with a 4-mm Allen wrench (Fig. 1).
2. Remove the O-Ring (25) from the OR seat (15).
3. Remove the sintered filter (7) from the DIN connector body (24), turning the first stage over.

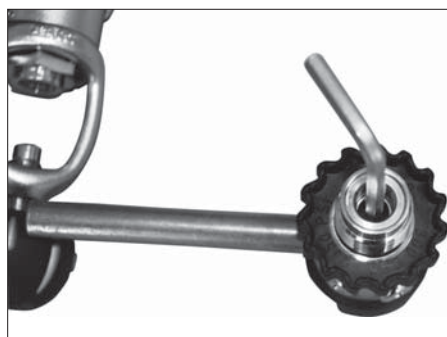
FIG. 2

4. Insert an 5-mm Allen wrench (B-4) inside the DIN fitting (24) and unscrew it completely (Fig. 2).
5. Remove the DIN fitting (24) and the DIN ring nut (11).
6. Remove the O-Ring (26) from the DIN fitting body (24).

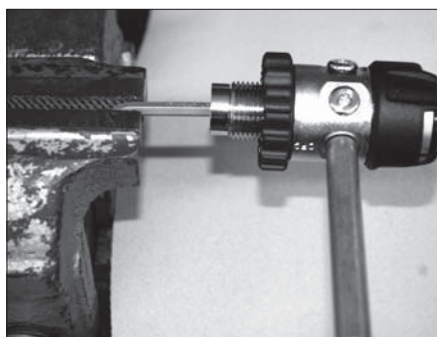
FIG. 3

NOTE TO MAKE DISASSEMBLY EASIER, MARES RECOMMENDS PLACING THE 5-mm ALLEN WRENCH (B-4) IN A BENCH VISE AS SHOWN IN THE PHOTO. (FIG. 3)

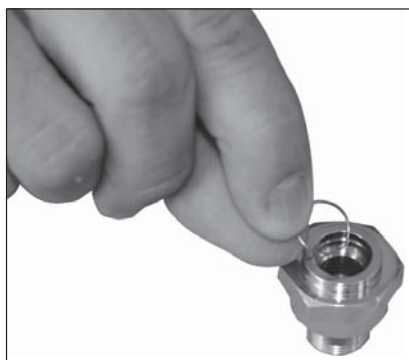
FIG. 1

1. Place the yoke retainer nut (23), the filter spring (12), and the INT tapered sintered filter (8) in the body (Fig. 1 and Fig. 2).
2. Using the snap ring pliers (B-14), fit the snap ring (2) in its position above the sintered filter (8) (Fig. 3).

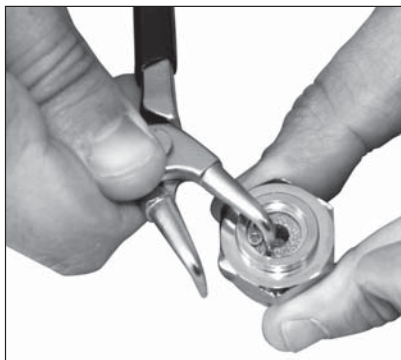
FIG. 4

ROTATE THE SNAP RING TO CHECK THAT IT IS POSITIONED CORRECTLY AS SHOWN IN THE PHOTO (FIG. 4).

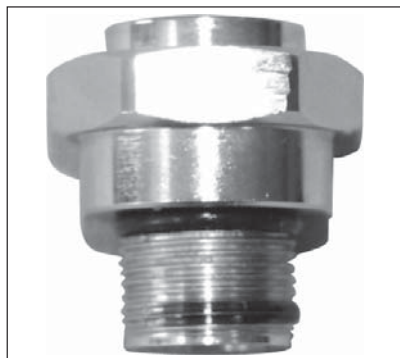
FIG. 5

TO PREVENT THE YOKE RETAINER NUT FROM WORKING LOOSE ACCIDENTALLY, POUR ONE OR TWO DROPS OF THREAD COMPOUND (LOCTITE 422 TYPE) ONTO ITS THREADING AS SHOWN IN THE PHOTO (FIG. 5).

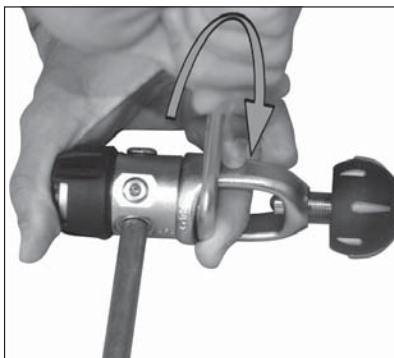
FIG. 6

3. Position the yoke (21) with the knob (16) on the first stage body.
4. Position the O-Ring 2050 (26) on the Yoke retainer nut (23).
5. Using the wrench (B-1), fully tighten the complete yoke retainer nut (7). (Fig. 6)

NOTE IF USING A TORQUE WRENCH, USE TIGHTENING TORQUE OF APPROXIMATELY 18-20 N/M.

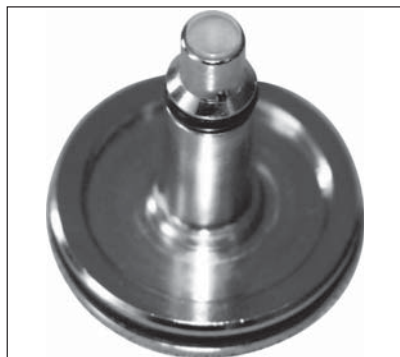
FIG. 8

6. Reassemble the seat (27) and the O-rings (17) and (20) on the piston (18) (Fig. 8).
7. Place the piston unit inside the cap (19) (Fig. 9).
8. Position the tool (B-5) inside the first stage body (Fig. 10).

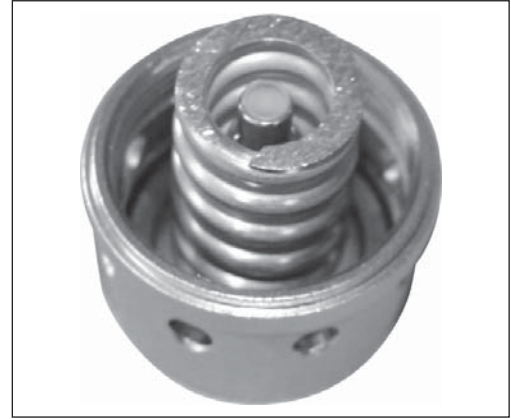
FIG. 11

10. Grease the bases of the spring (4) and place it inside the cap (19) (Fig. 11).
11. Screw the cap (19) onto the first stage body (1) and tighten it down fully using the wrench (B-23) (Fig. 12).
12. Position the O-Rings 5 and 13 on the corresponding low (6) and high pressure port caps (14) and/or on the corresponding hoses.
13. Screw the caps and/or hoses into the appropriate seats on the first stage.

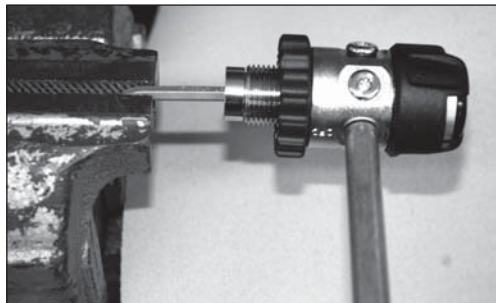
FIG. 2

2. Position the DIN ring nut (11) on the first stage body (1), and then fully screw down the coupling (24) using the 5-mm Allen wrench (B-4) (Fig. 2).

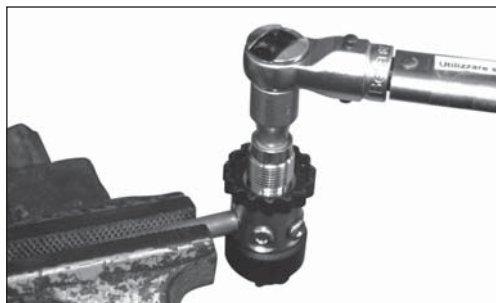
FIG. 3

WARNING!
MARES RECOMMENDS USING A TORQUE WRENCH. SET A TIGHTENING TORQUE OF APPROXIMATELY 18-20 N/M. (FIG. 3)

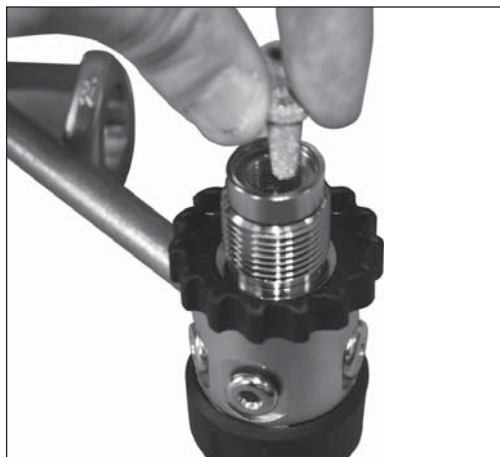
FIG. 4

3. Insert the tapered filter (7) into the DIN connector. (Fig. 4)

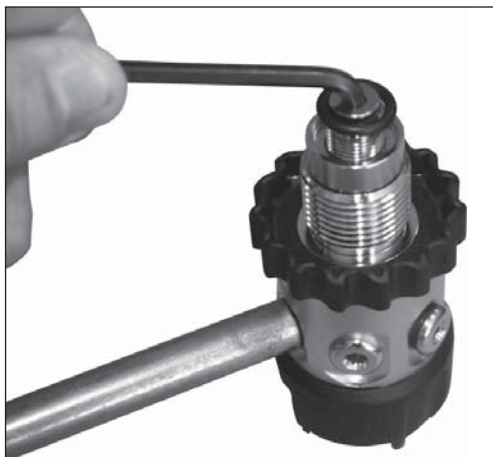
FIG. 5

4. Position the O-Ring (25) on the OR seat (15).
5. Screw the O-Ring housing (115) to the DIN coupling (24) with a 4-mm Allen wrench and unscrew the disassembly tool (B-5) from the first stage body. (Fig. 5)

NOTE IF USING A TORQUE WRENCH, USE TIGHTENING TORQUE OF APPROXIMATELY 1.5 - 2 N/M.

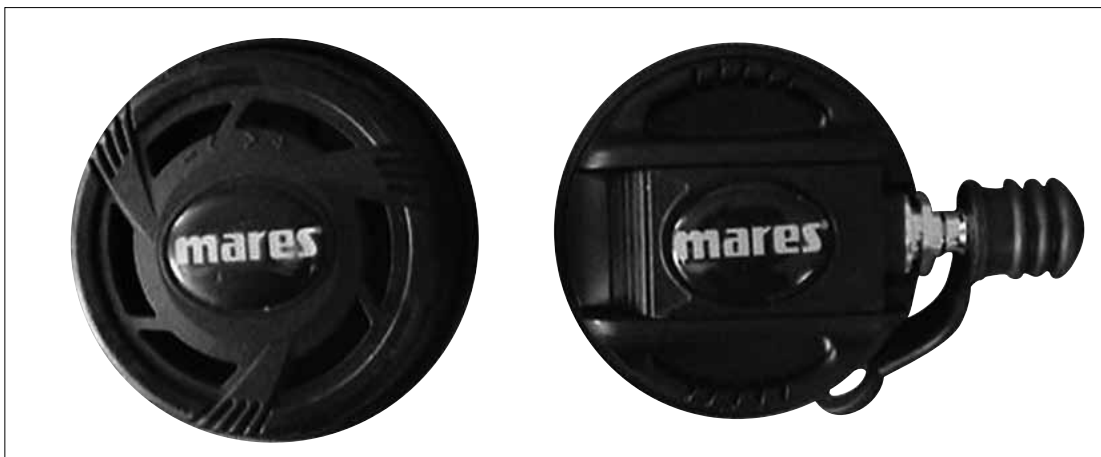
SITECH VERSION

BELOW YOU CAN CHECK THE TWO VERSIONS AND THEIR CORRESPONDING REPLACEMENT PART CODES, WHICH REFER TO COMPLETE, TESTED VALVES.

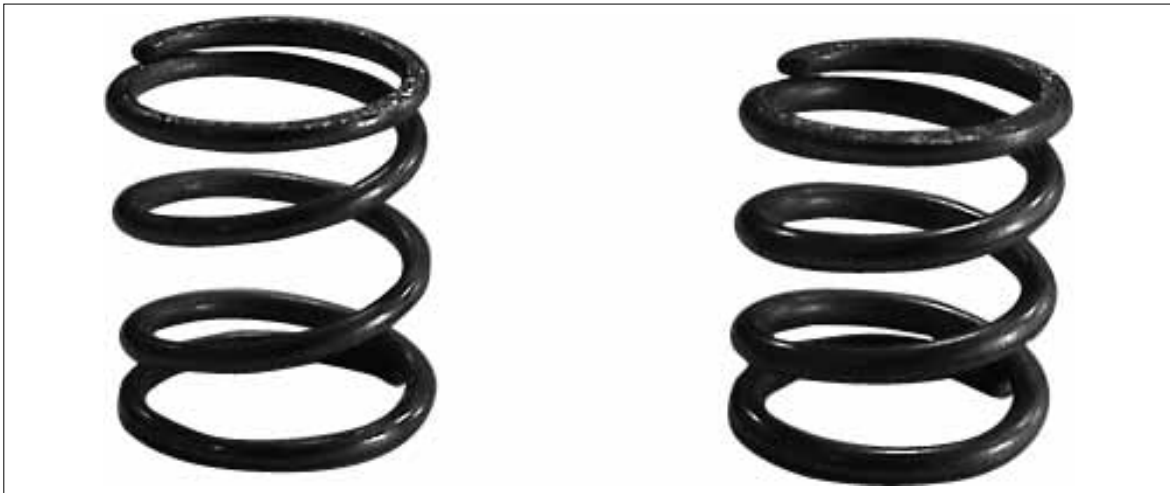
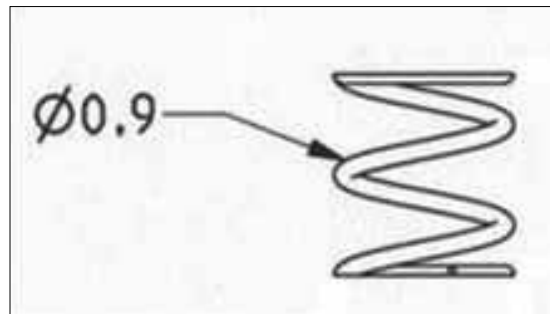
FIG. 1

MARES S.P.A TECHNICAL SUPPORT ANNOUNCES THAT A NEW SPRING WILL BE ASSEMBLED FOR THE INFLATION BUTTON ON AIR-CONTROL (**CODE 416893**) THAT HAS SLIGHTLY GREATER THRUST THAN THE PREVIOUS SPRING AND ENSURES PERFECT OPERATIONS EVEN IN EXTREME CONDITIONS (DIRTY OR CONTAMINATED WATER).
THE NEW INFLATION BUTTON SPRING WILL BE ASSEMBLED BEGINNING FROM SERIAL NUMBER: **EC13569**.
THE CODE OF THE NEW VERSION IS #46201113. THE NEW SPRING CAN BE IDENTIFIED BY MEASURING THE DIAMETER OF THE SPIRAL, WHICH IS 0.9~MM (FIG. 1 AND FIG. 2).

PREVIOUS VERSION
COD. 47200744

CURRENT VERSION
COD. 46201113

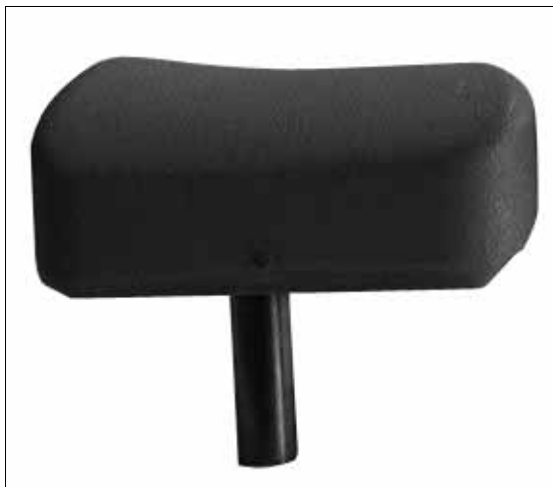
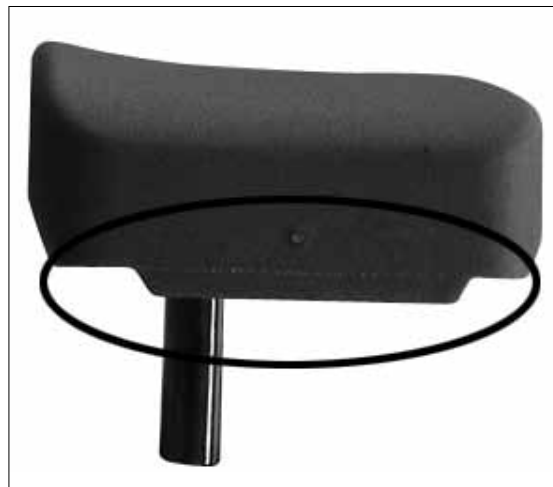
FIG. 1

THE COMPONENT CODE REMAINS UNCHANGED (**#46201019**); IN ANY EVENT THE NEW VERSION CAN BE RECOGNIZED BECAUSE OF ITS DIFFERENT SHAPE, AS SHOWN IN FIG. 1.

PREVIOUS VERSION

CURRENT VERSION
